CENTRAL VALLEY WATER BOARD STAFF SITE VISIT WRITE-UP

City of Colusa

Wastewater Treatment Plant, Colusa County

6 March 2012

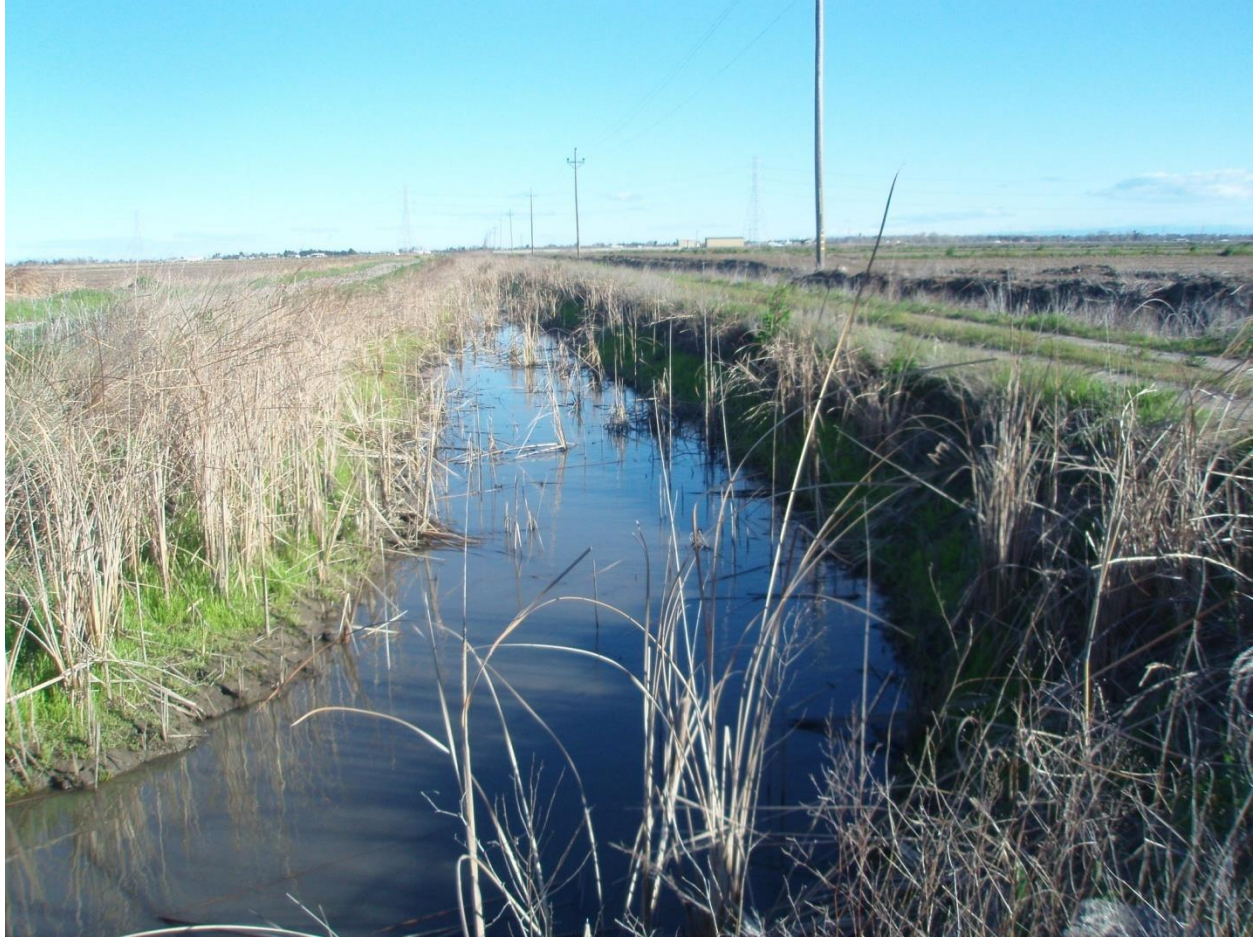
Photo 1: Unnamed Tributary at the RSW-001U site, looking upstream.

The first site visited was the RSW-001U, the Unnamed Tributary upstream of effluent discharge (Photo 1). The channel had a fair amount of water, but the flow was very slow. The NPDES samples for this site are normally taken prior to the channel going under the road at the weir. City Staff indicated that the receiving water was made up of irrigation discharge and urban runoff from the City of Colusa as well as storm water during rain events. Data collected as follows:

GPS coordinates = 39.17431, -122.03136

Water Temp = 8.92 °C

pH = 7.7

Dissolved Oxygen = 6.76 mg/L

Specific Conductivity = 1379 µS/cm

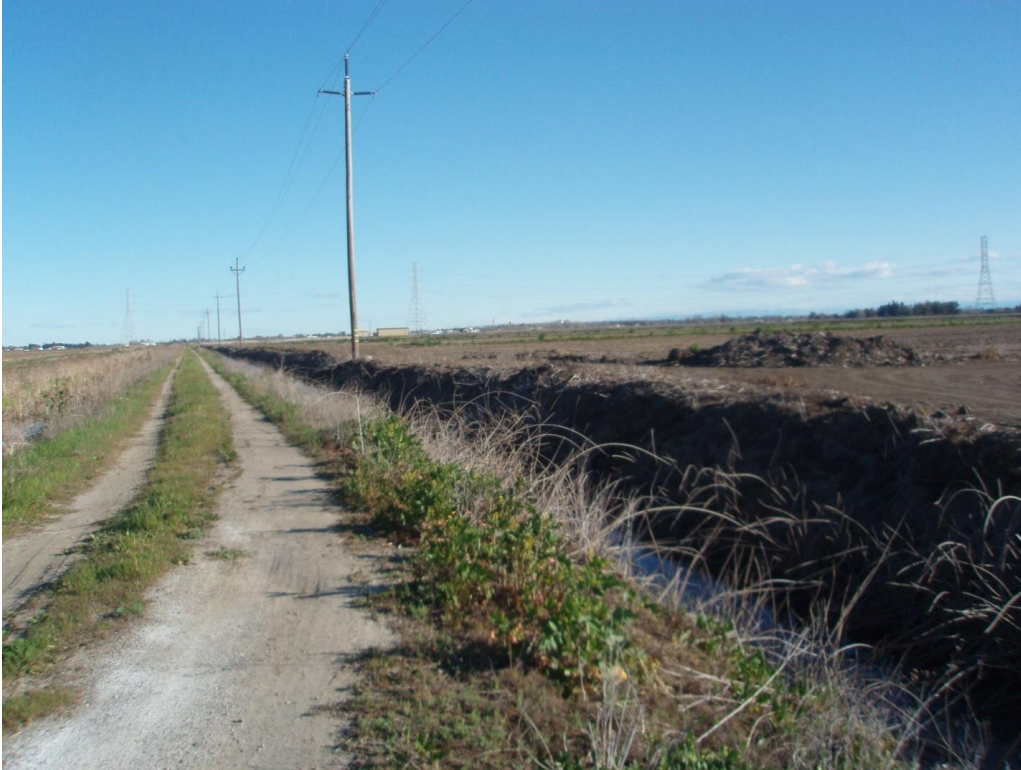
Photo 2: New Ditch, dug about 6-7 months ago, adds a second arm to Unnamed Tributary upstream of effluent discharge

City staff indicated that within the last 6-7 months (estimated at Aug-Sept 2011), an additional channel was dug by the landowner along the other side of the road, thereby adding an additional source of upstream receiving water. This channel is used for irrigation tailwater from the rice fields. The source of the water was most likely groundwater from the new wells that had been dug on the landowner's property. No water sampling has been conducted on the water from this new arm of the channel shown in Photo 2. Water was flowing in the new channel, but was low compared to the salt deposit line shown in Photo 3. Because the RSW-001U no longer represents the upstream receiving water in its entirety, a consideration should be made for adding a site to this portion of the channel for the project.

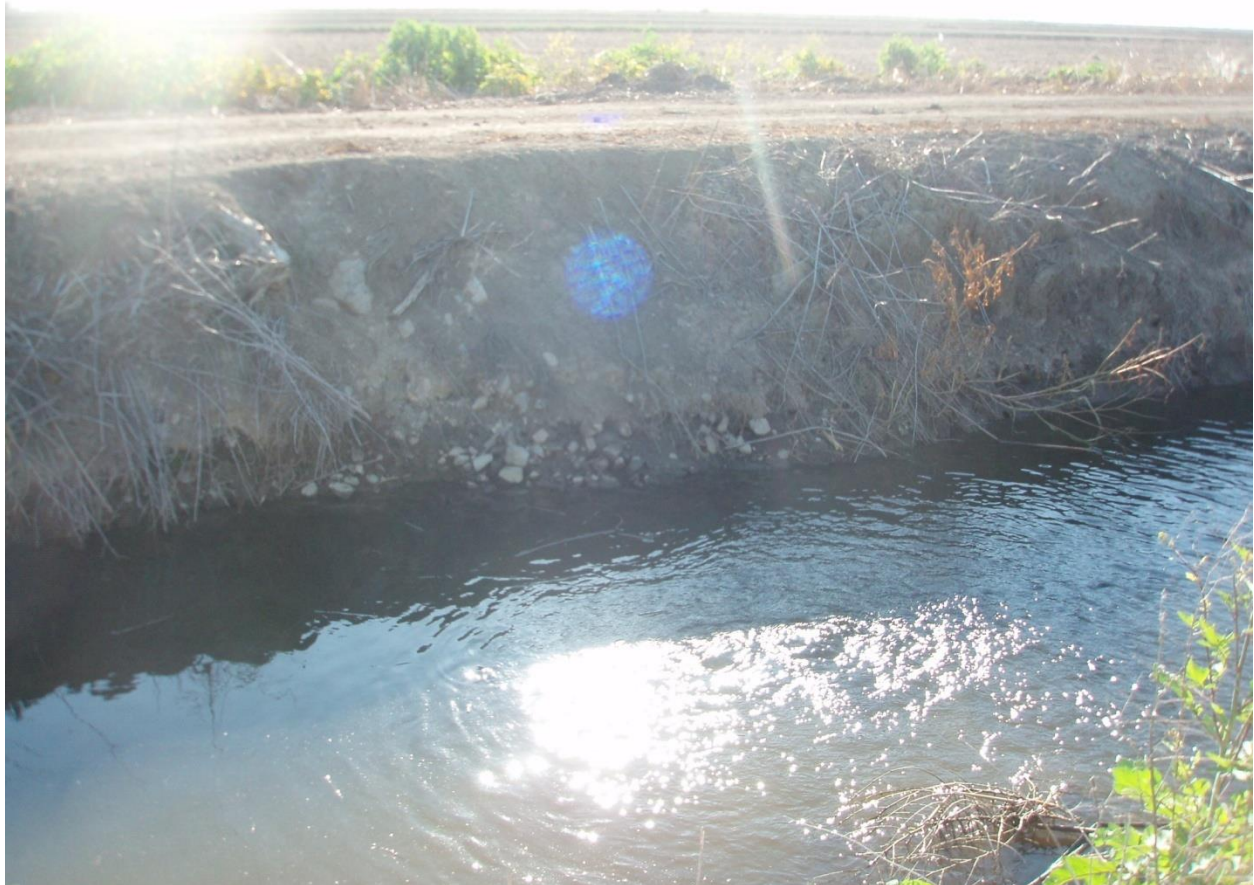
Photo 4. Effluent outfall into Unnamed Tributary

The next photograph (Photo 4) shows the location of the effluent discharge into the Unnamed Tributary. The bubbling circle in the middle of the picture indicates the effluent was actively discharging during our visit. (GPS coordinates = 39.17391,-122.031252)

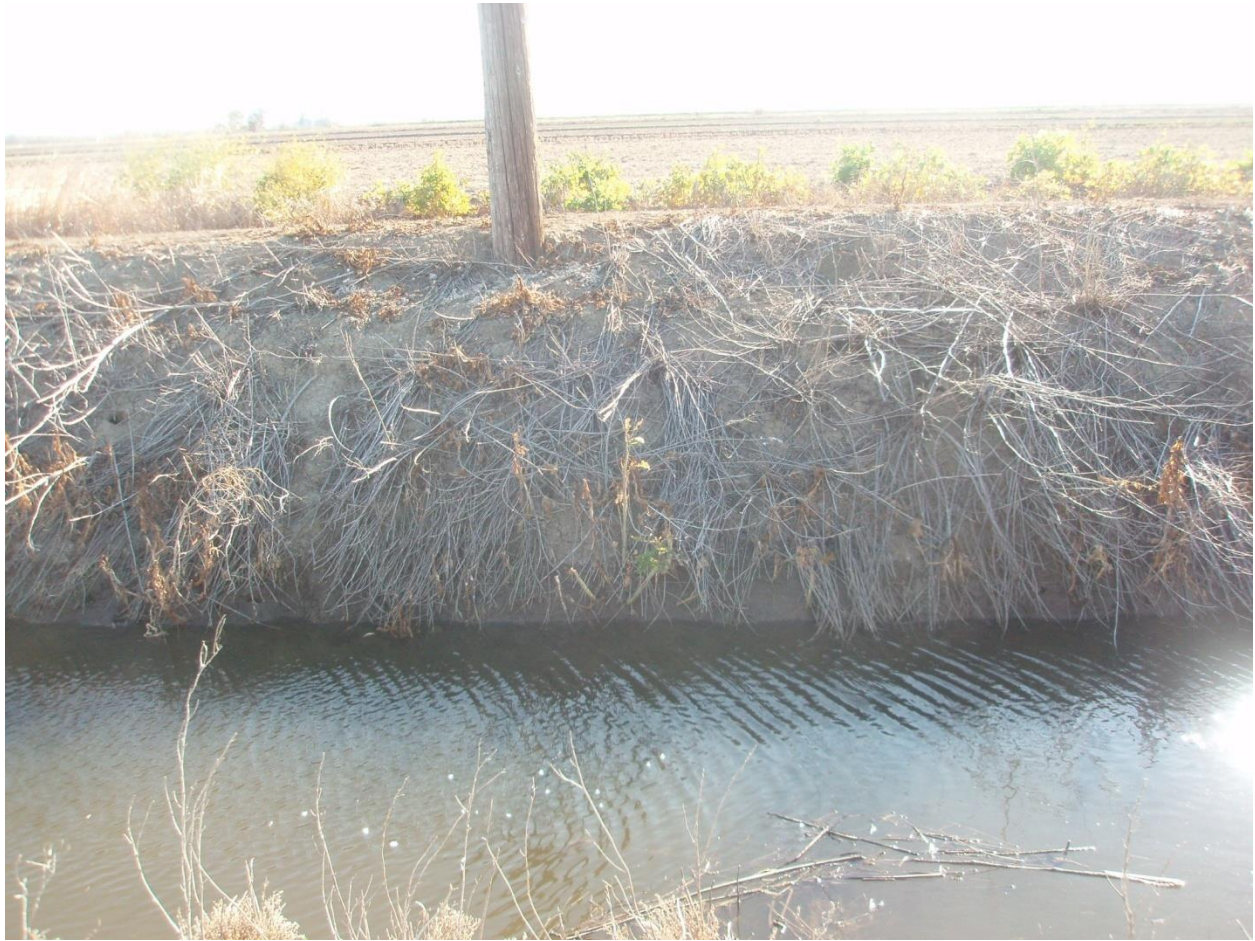
Photo 5. Unnamed Tributary at the RSW-001D receiving water monitoring site

The next receiving water site was RSW-001D, approximately 200 ft downstream of the effluent discharge point in the Unnamed Tributary (Photo 5). The NPDES samples are usually collected directly across from the telephone pole. Data collected as follows:

GPS coordinates = 39.171444,-122.031252

Water Temp = 13.51 °C

pH = 7.84

Dissolved Oxygen = 7.62 mg/L

Specific Conductivity = 1051 µS/cm

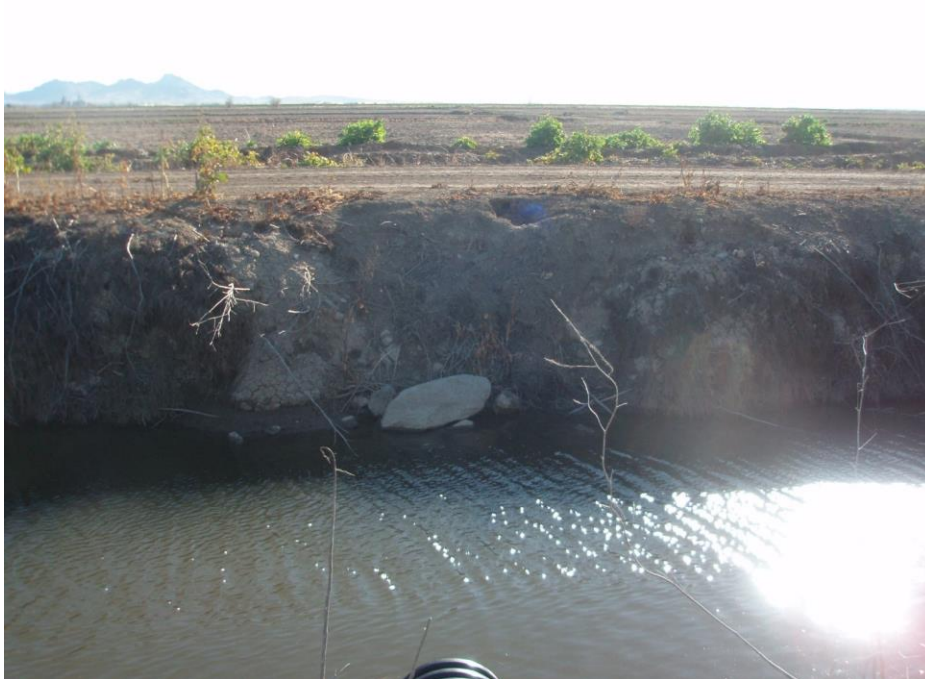
Photo 6: Pipe carrying water from the rice fields to the Unnamed Tributary.

Downstream from RSW-001D, several pipes for transporting water off of the rice fields into the Unnamed Tributary were located. Rice fields were still dry for this visit so no water was flowing from the pipes. Photo 6 shows the pipe located at the GPS coordinates = 39.170635,-122.031282.

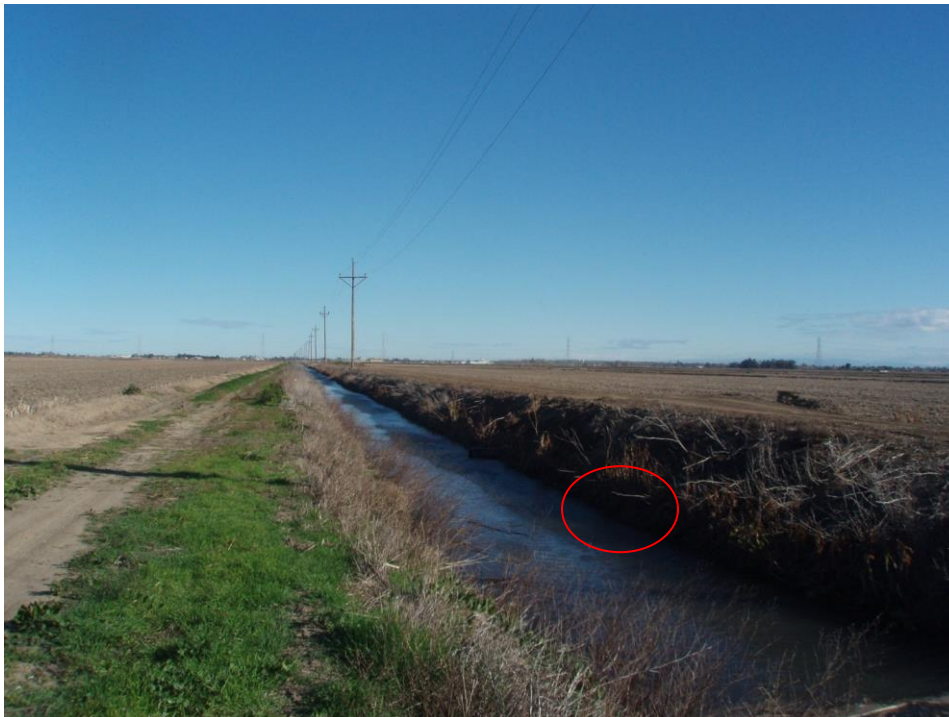
Photo 7. Unnamed tributary, prior to the “bend” and its confluence with Powell Slough.

City staff indicated that a new pipe had been installed to drain the rice fields, just prior to the “bend” in the Unnamed Tributary at the GPS coordinates = 39.167154,-122.031233. Photo 7 shows it circled in red entering the Unnamed Tributary looking upstream.

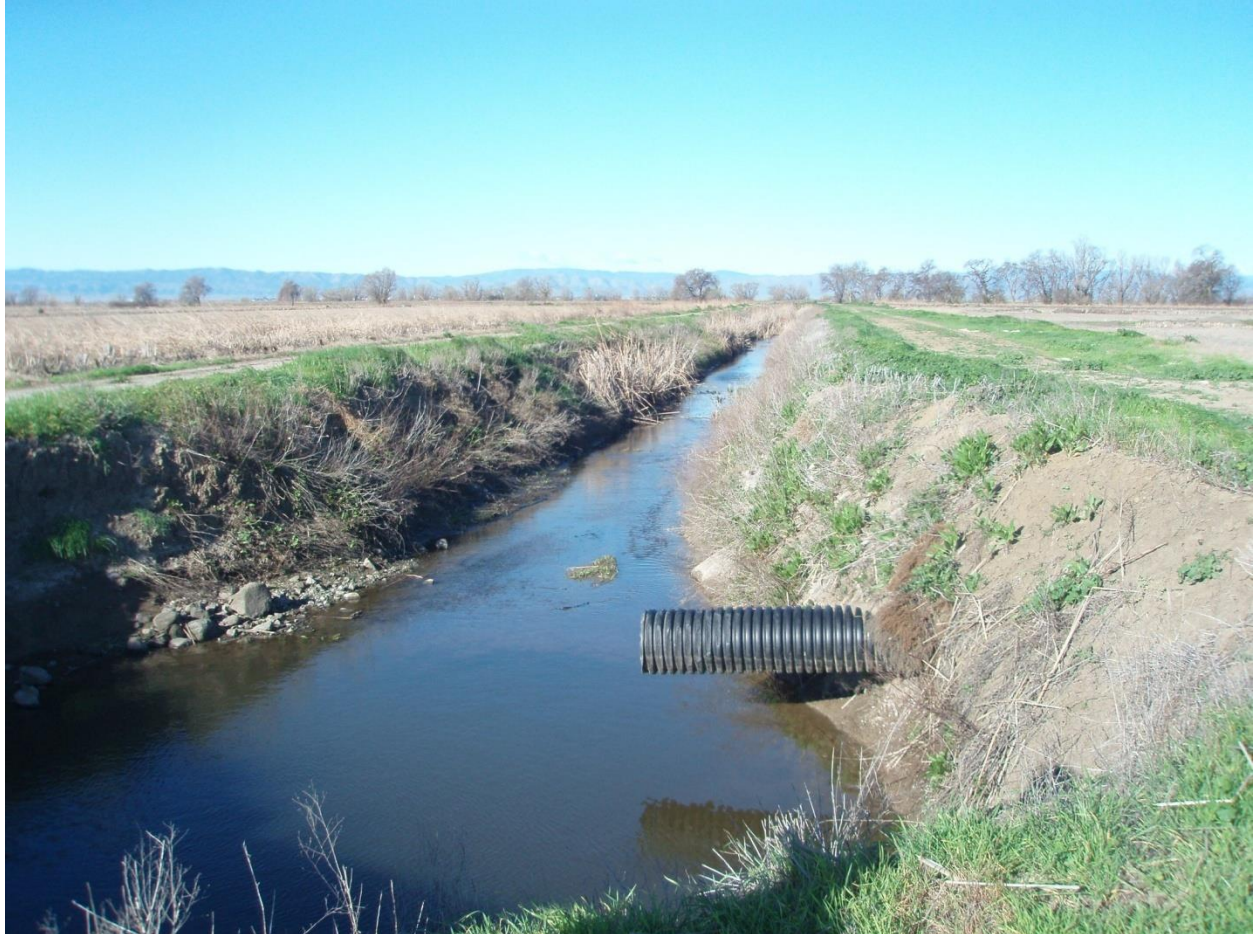
Photo 8. Unnamed Tributary looking downstream towards Powell Slough.

The Unnamed Tributary bends and flows under the road at the GPS coordinates = 39.16697, -122.03135. Photo 8 shows the Unnamed Tributary looking downstream towards Powell Slough after the “bend”. Another pipe from the rice fields can be seen at this location.

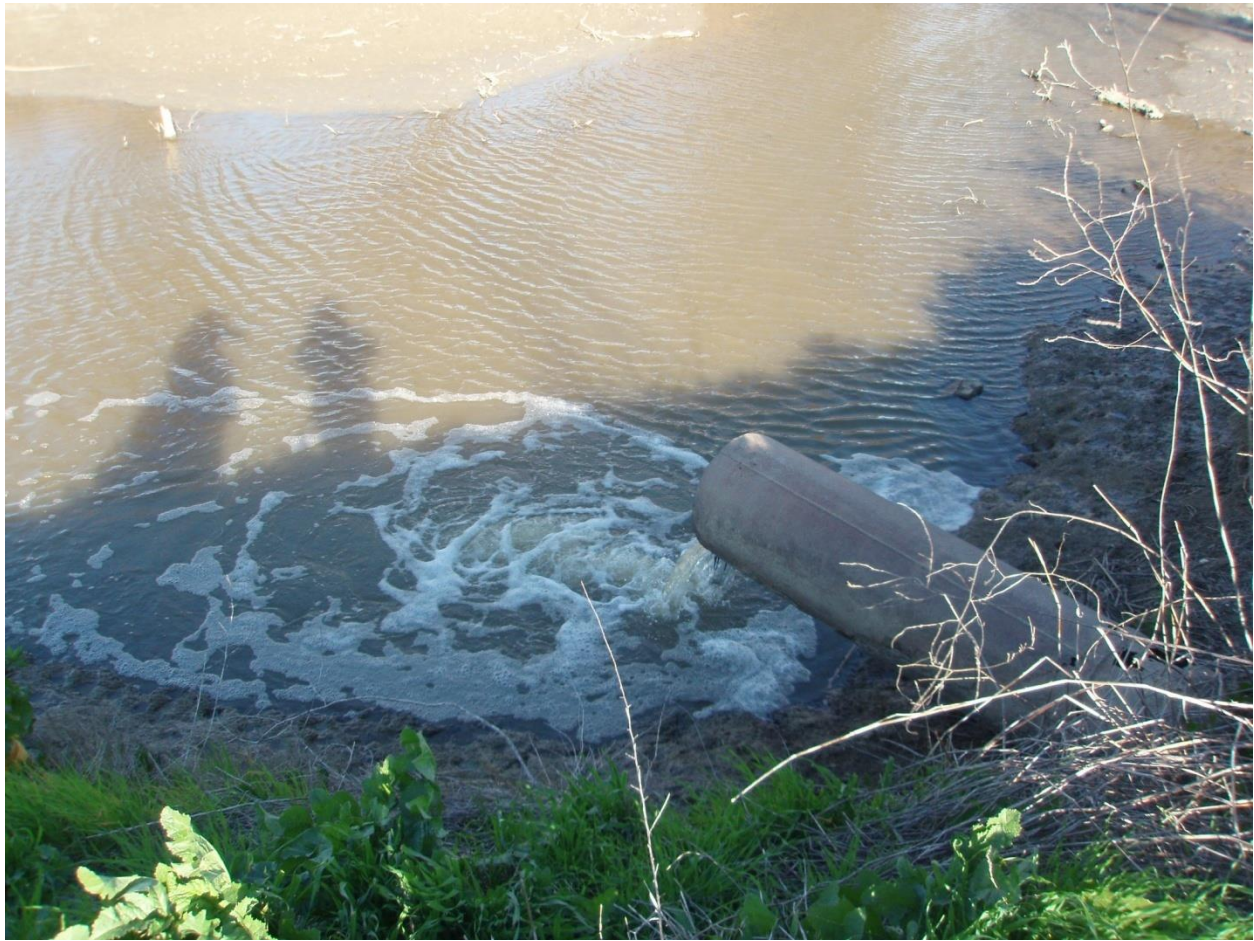
Photo 9. Pipe that contains the flow from the Unnamed Tributary in to Powell Slough

The next stop was at the confluence of the Unnamed Tributary and Powell Slough. A pipe runs under the roadway at the end of the the Unnamed Tributary and in to the slough as see in Photo 9 (GPS coordinate = 39.16683,-122.03495).

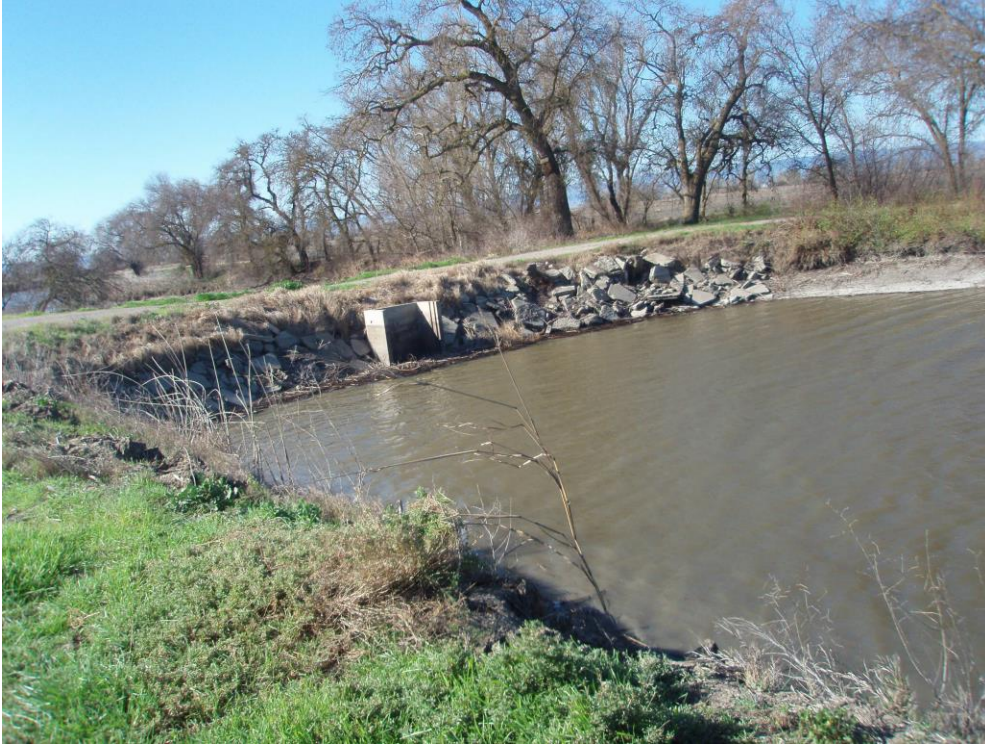
Photo 10. Powell Slough, looking downstream at the weir for the RSW-002U site

The City of Colusa's CWTP has two receiving water monitoring sites in Powell Slough in addition to the two in the Unnamed Tributary. RSW-002U is approximately 250 feet upstream from the confluence of the Unnamed Tributary and Powell Slough at a weir as shown in Photo 10. This area is blocked off from the remaining portion of Powell Slough and filled for irrigation water. Holding the water for a period of time also warms the water prior to using it on the rice fields. Data collected as follows:

GPS coordinates = 39.167805,-122.034801

Water Temp = 8.13 °C

pH = 8.78

Specific Conductivity = 2091 $\mu\text{S}/\text{cm}$

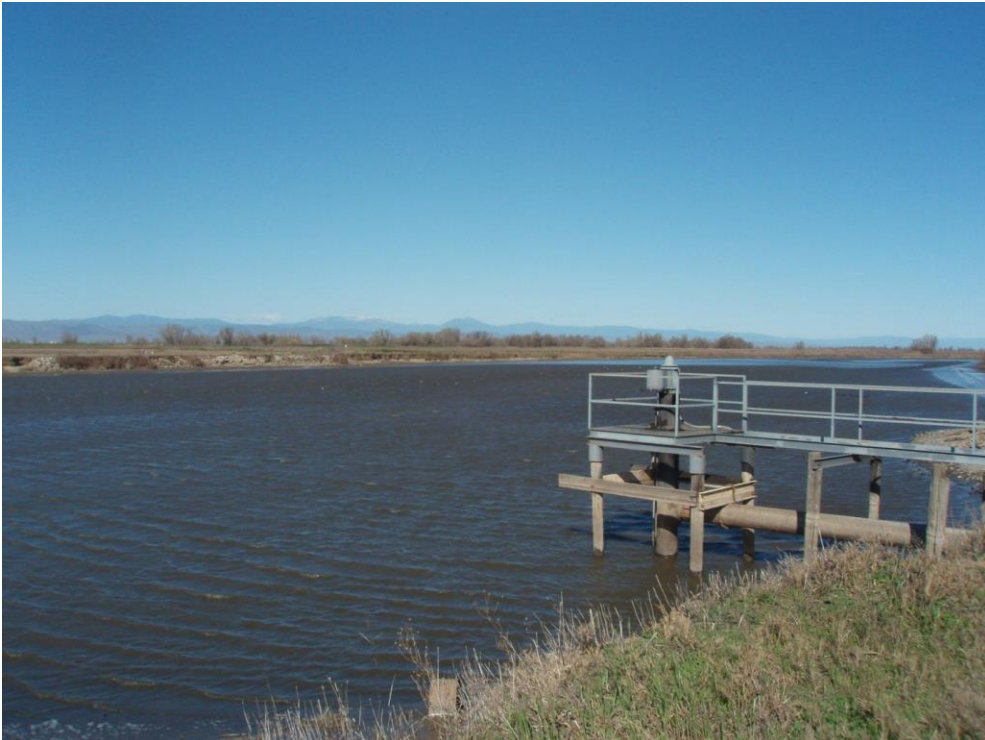
Photo 11. Expanded area of Powell Slough north of RSW-002U. Pump is used for irrigation.

Upstream of RSW-002U on Powell Slough, the channel becomes quite large. When Powell Slough is full, the pump shown in Photo 11 is used to take water out for irrigation to the rice field (GPS coordinates = 39.173611,-122.036702).

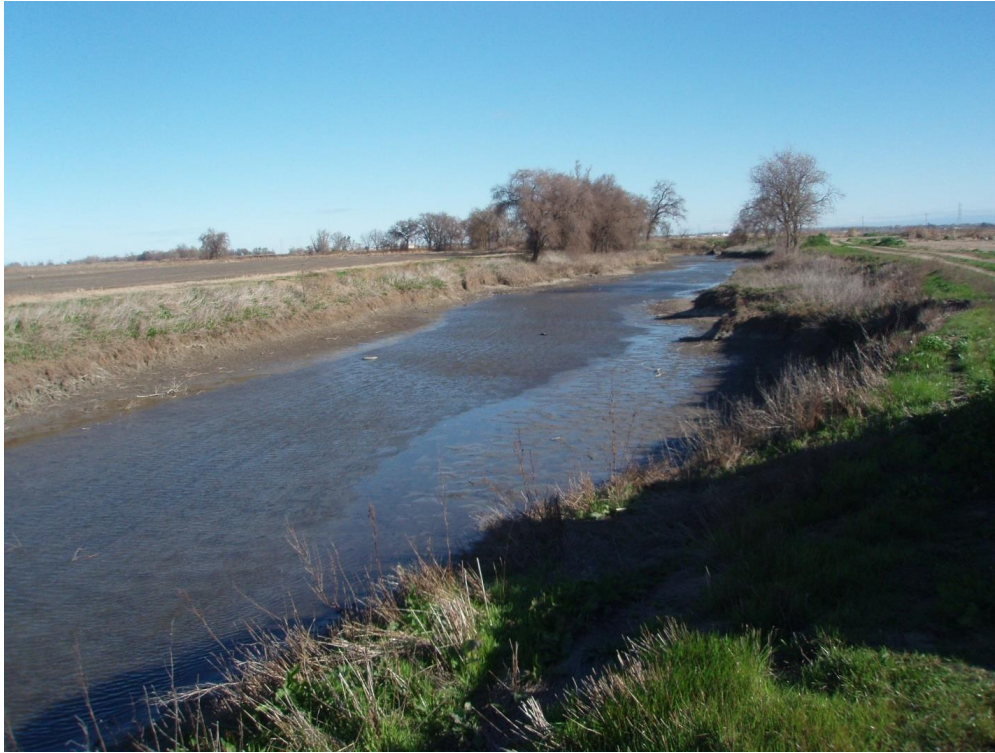
Photo 12. Powell Slough, 400 feet downstream from the confluence of the Unnamed Tributary

The next site was RSW-002D, approximately 400 feet downstream of the confluence with the Unnamed Tributary (GPS coordinates = 39.16553,-122.03563) as shown in Photo 12.

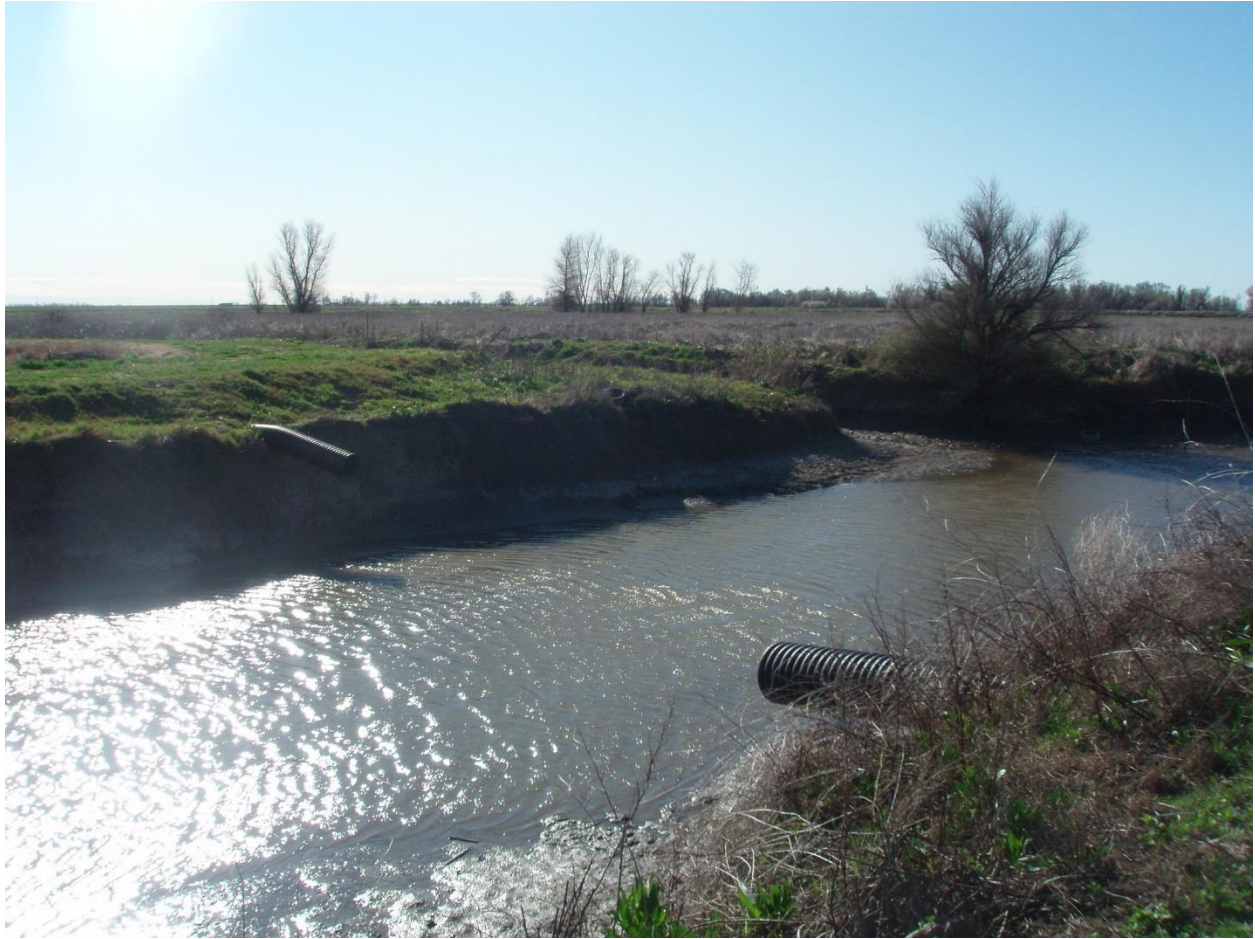
Photo 13. Discharge from rice fields into Powell Slough, downstream of RSW-002D

Downstream of the RSW-002U and RSW-002D sites, no water is taken from Powell Slough for irrigation but there are several other outflows from the fields. Photo 13 shows two pipes and a canal that discharge water into Powell Slough (GPS coordinates = 39.163409,-122.037764). No water from these sources was seen during this site visit.

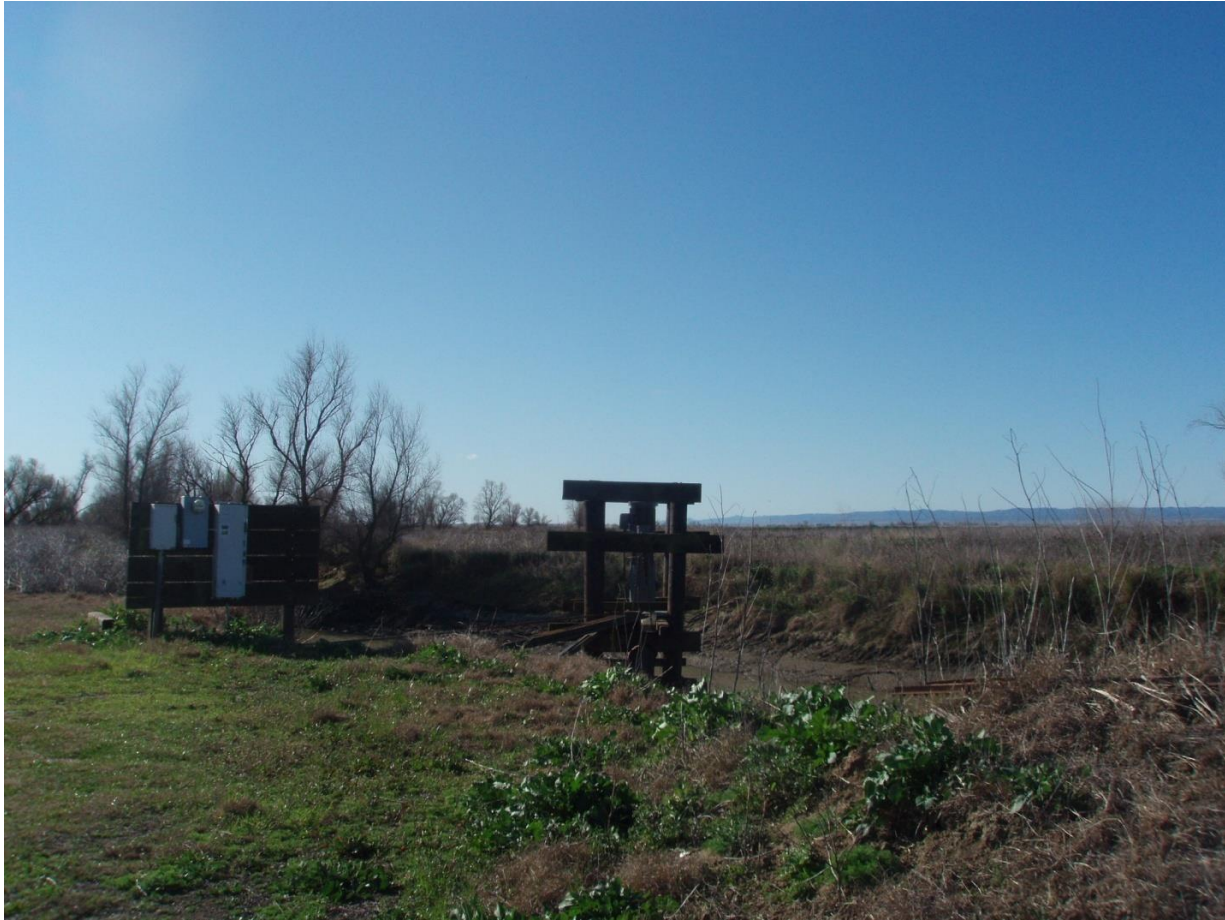
Photo 14. Colusa Basin Drain at Pump Structure

Past this section of Powell Slough, the road heads east towards Colusa Basin Drain, upstream of its confluence with Powell Slough. At the end of the road, there is a pump structure (GPS coordinates = 39.162698,-122.040765), shown in Photo 14, which takes water from Colusa Basin Drain and into a ditch that runs north alongside the closest northeast field. This water is used for irrigation in the rice fields. The agricultural runoff from these fields goes back into Powell Slough.

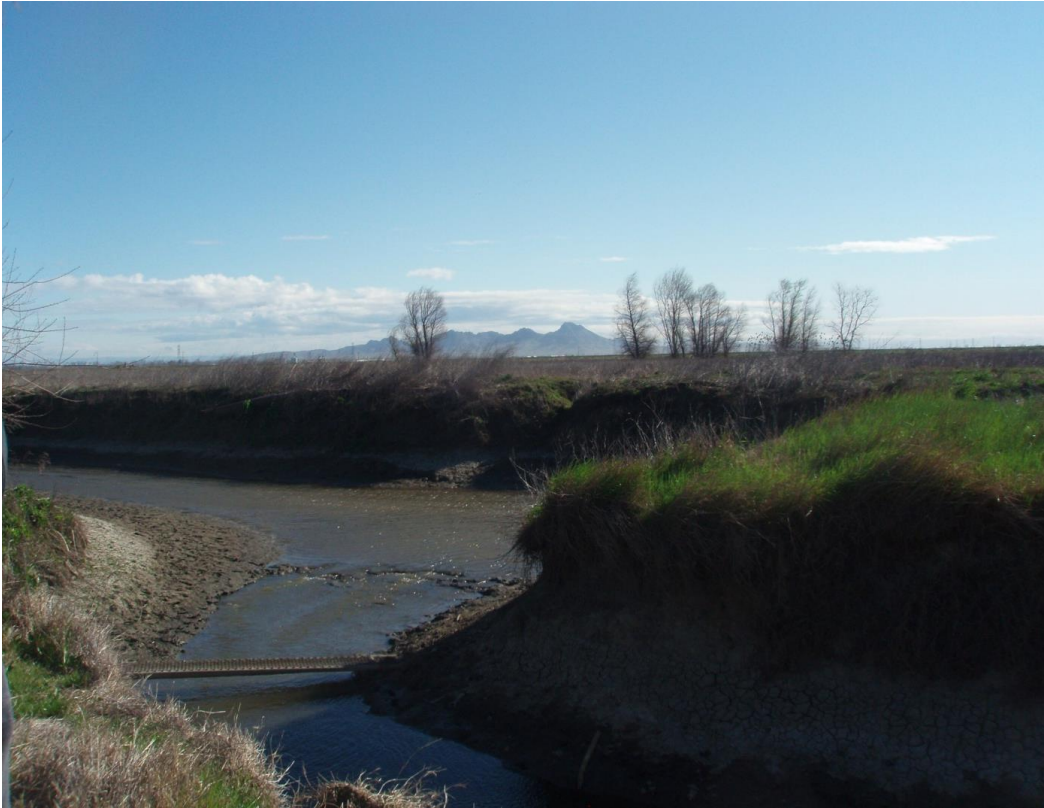
Photo 15. Powell Slough immediately upstream of its confluence with the Colusa Basin Drain

Since the conditions were dry and no rain events had occurred recently, it was possible to continue driving southeast along Colusa Basin Drain towards its confluence with Powell Slough. City staff cautioned that this road would not be safe for supporting a vehicle during the wet season and the Powell Slough confluence area would not be safely accessible to sample. Photo 15 shows Powell Slough just upstream its confluence with Colusa Basin Drain (GPS coordinates = 39.161425,-122.038349). There is an island that causes Powell Slough to fork just prior to entering the drain. Photo 16 shows evidence of a dam that had been used on one of the Powell Slough forks before its confluence with Colusa Basin Drain.

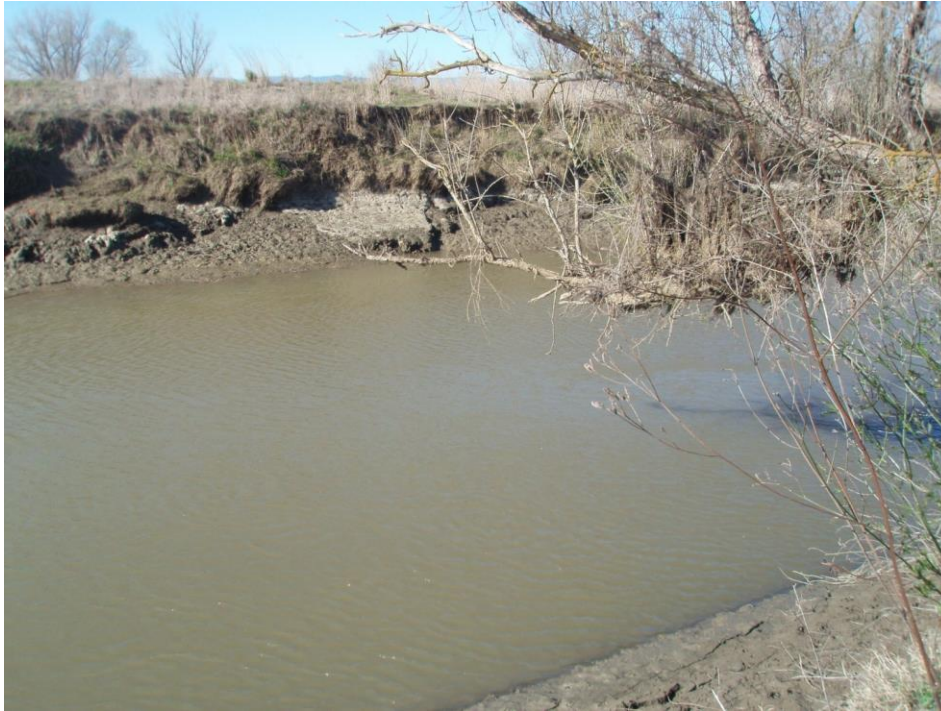
Photo 17. Colusa Basin Drain just upstream of the confluence with Powell Slough

Photos 17-19 show the Colusa Basin Drain upstream, at and downstream of its confluence with Powell Slough.

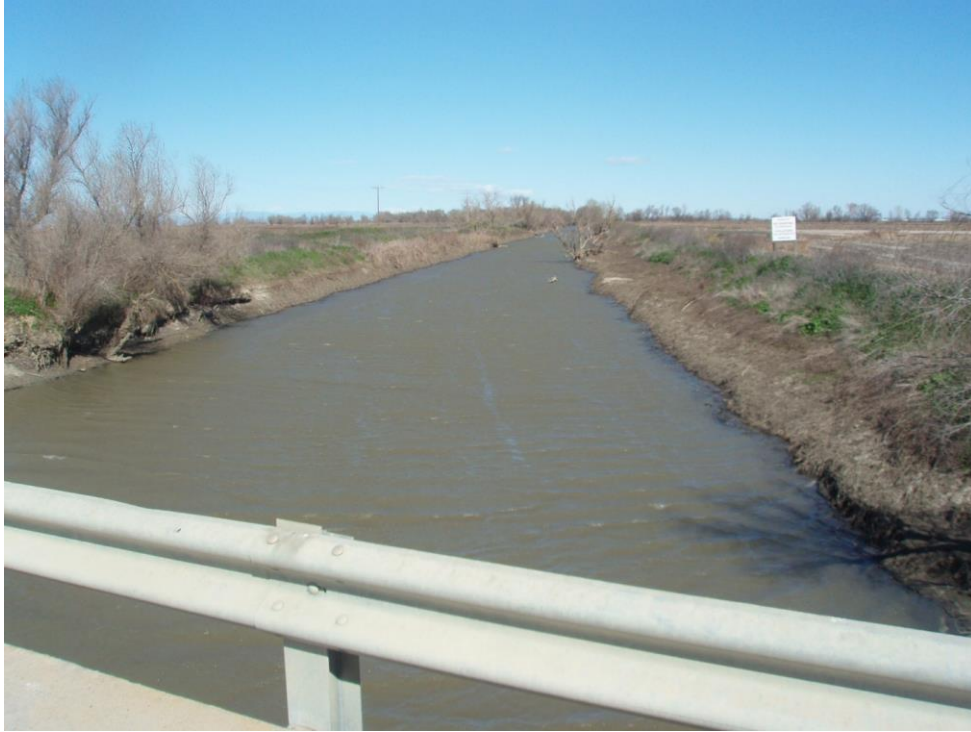
Photo 20. Colusa Basin Drain, downstream of the Powell Slough confluence at Abel Road Bridge

City staff directed Central Valley Water Board staff to two potential sampling sites on the Colusa Basin Drain that they had sampled at in the past. The first was approximately a mile downstream of the Powell Slough confluence at a bridge overcrossing on Abel Road (GSP coordinates = 39.144631,-122.027122) as seen in Photo 20. The second was Colusa Basin Drain at Hwy 20, upstream of the Powell Slough confluence (GPS = 39.19545,-122.06132) as seen in Photo 21. The photo also shows an overflow channel (circled in red) that goes to Powell Slough when the water is high enough. Photo 22 shows a closer look at this channel. Photo 23 shows a dry ditch on the opposite side from the channel to Powell Slough on Colusa Basin Drain that discharges water during the irrigation season.

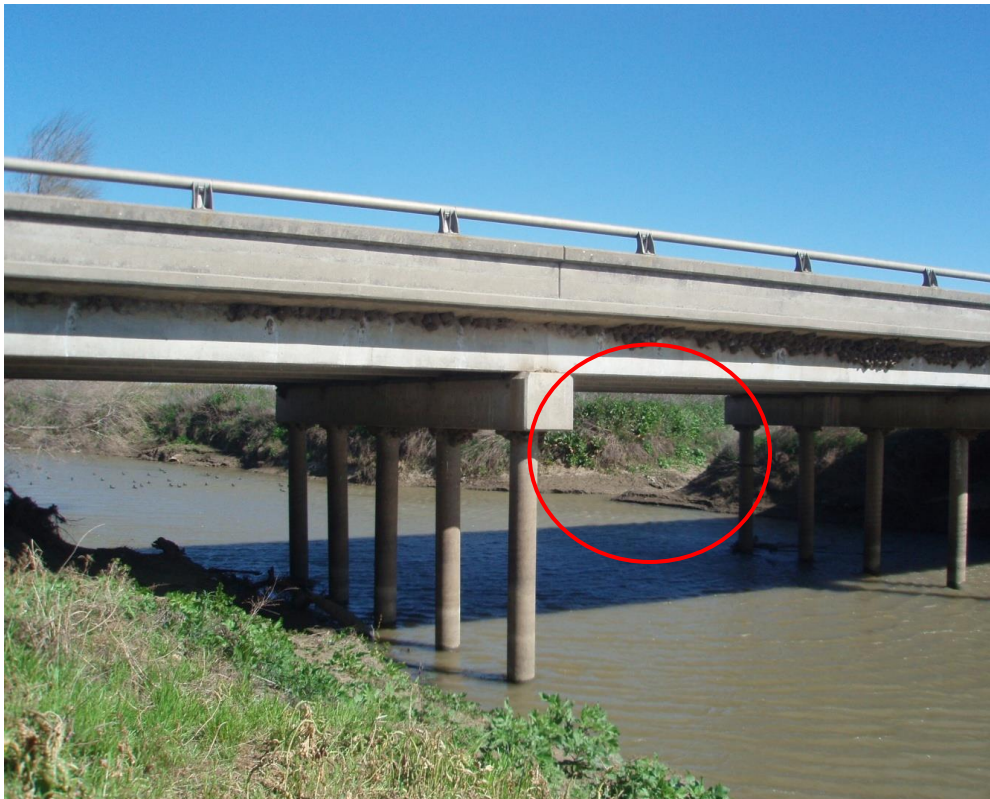
Photo 21. Colusa Basin Drain upstream of Powell Slough confluence at Hwy 20. The circled red area is where the over flow of the drain goes to a channel towards Powell Slough.

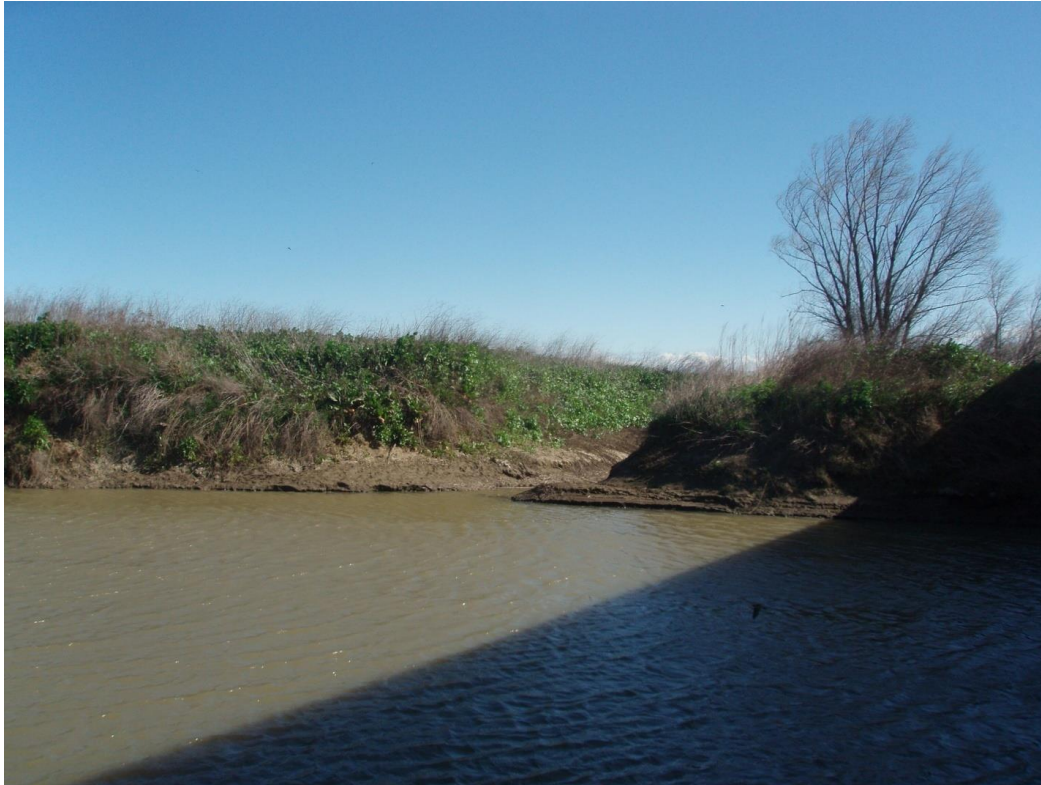
Photo 22. A closer look at the outflow channel to Powell Slough from the Colusa Basin Drain

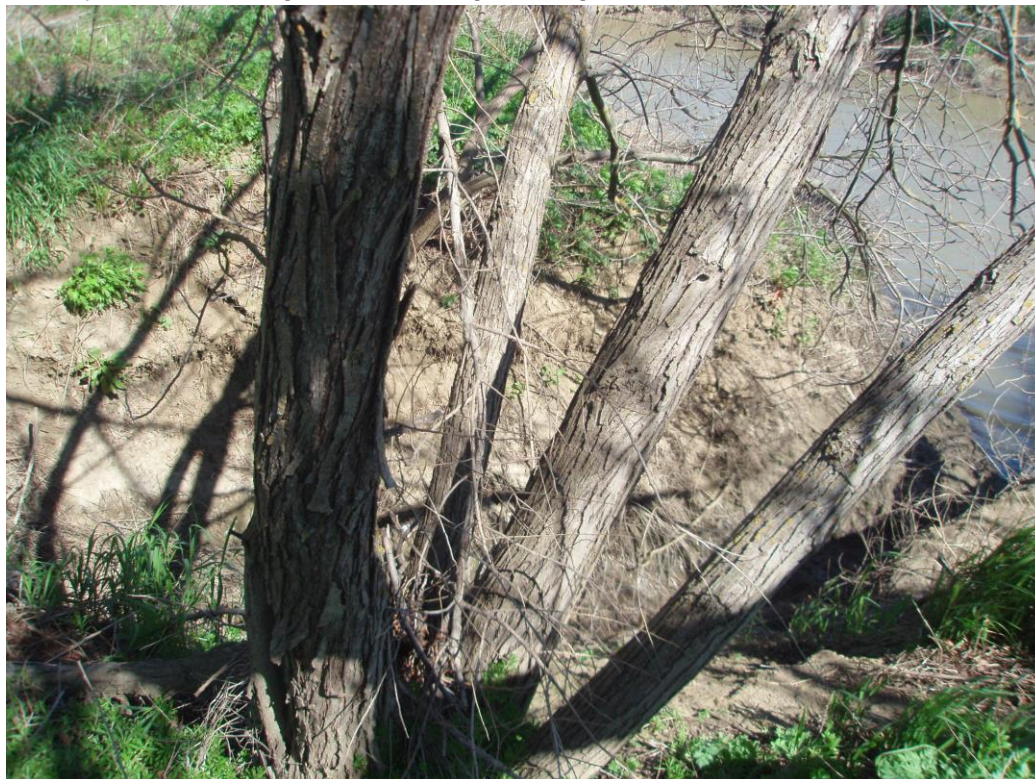
Photo 23. Ditch across from the Powell Slough overflow channel in Colusa Basin Drain. Ditch was dry, but carries Ag. run off during the irrigation season.

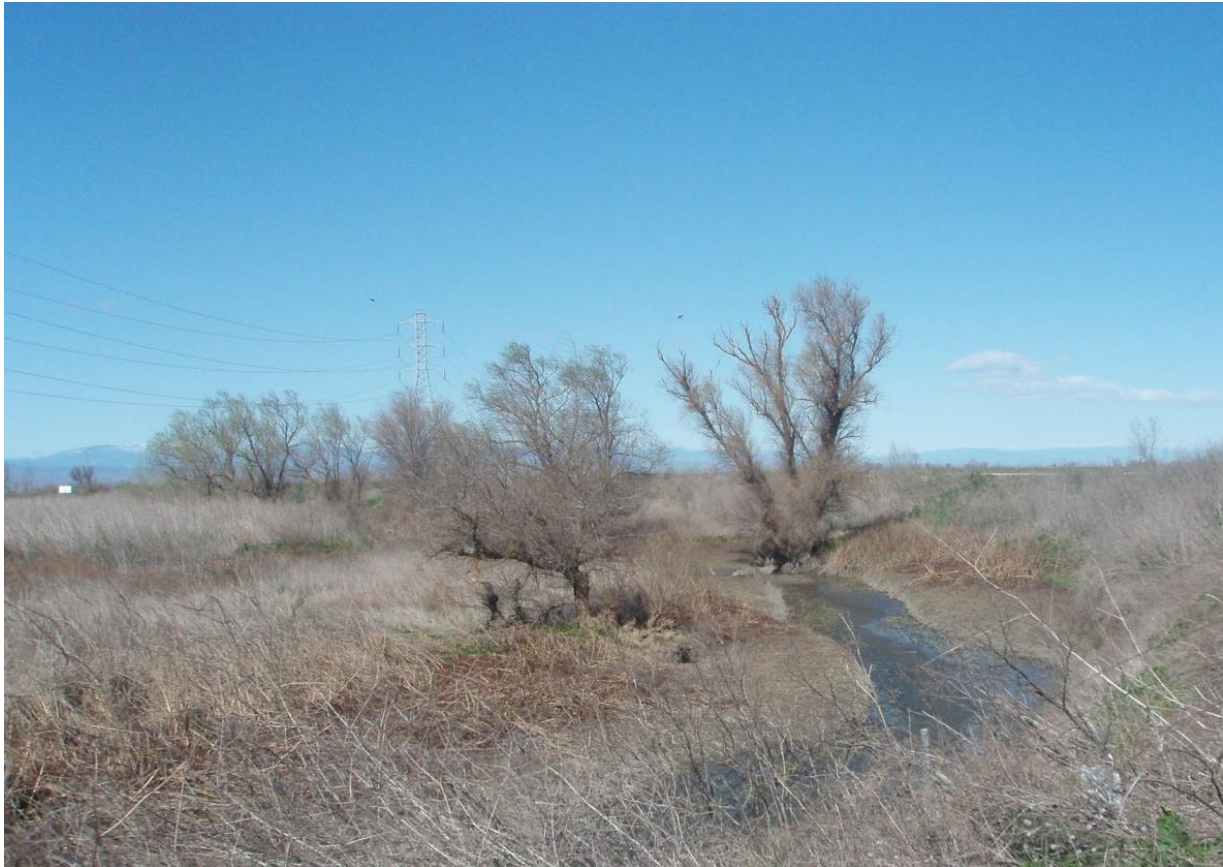
Photo 24. Powell Slough at Hwy 20, looking upstream to the north.

Highway 20 also crosses the northern section of Powell Slough east of the site at the Colusa Basin Drain. Photo 24 shows Powell Slough, looking upstream. The channel from the Colusa Basin Drain to Powell Slough runs parallel to Highway 20 as shown in Photo 25. Photo 26 shows the channel at a weir, looking downstream towards Powell Slough. In the background, a sign indicates that the land is part of "Wilderness Unlimited".

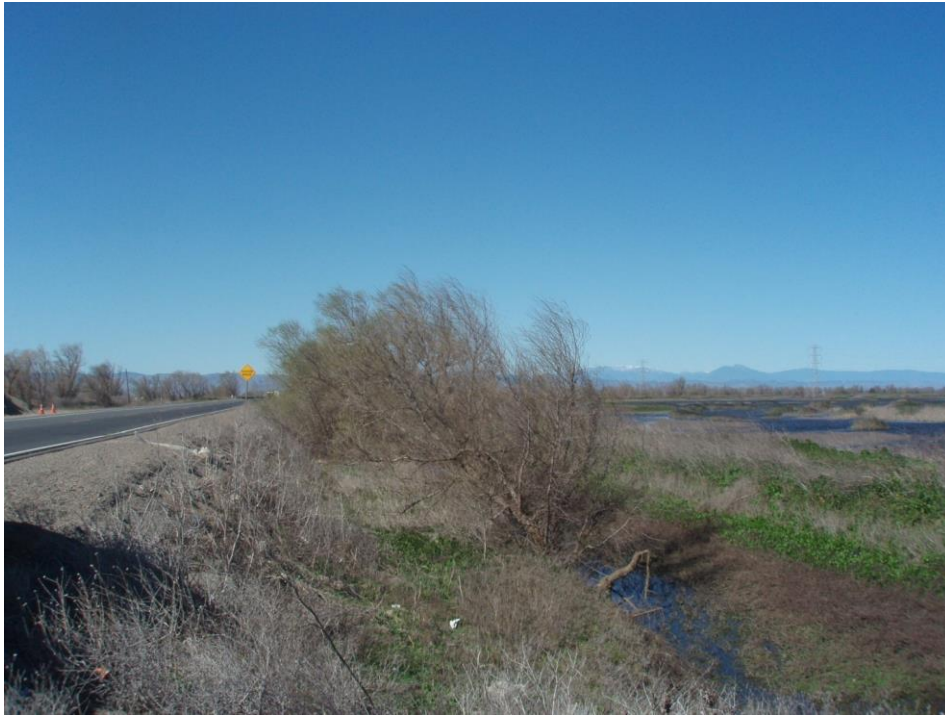
Photo 25. Channel along Hwy 20 carrying overflow water from Colusa Basin Drain to Powell Slough, looking upstream.
